Stag Restoration

by Terry Hunt

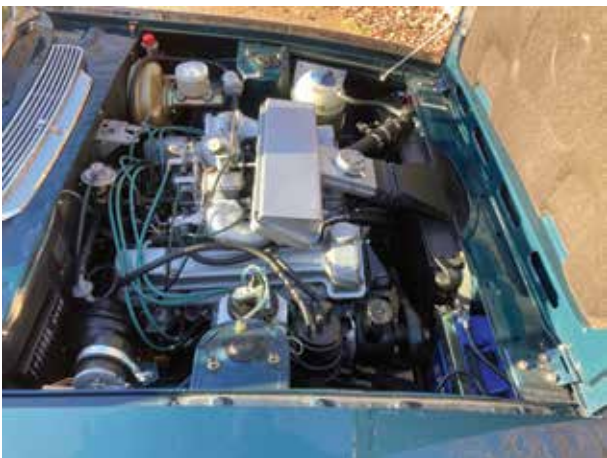
Very neat engine bay

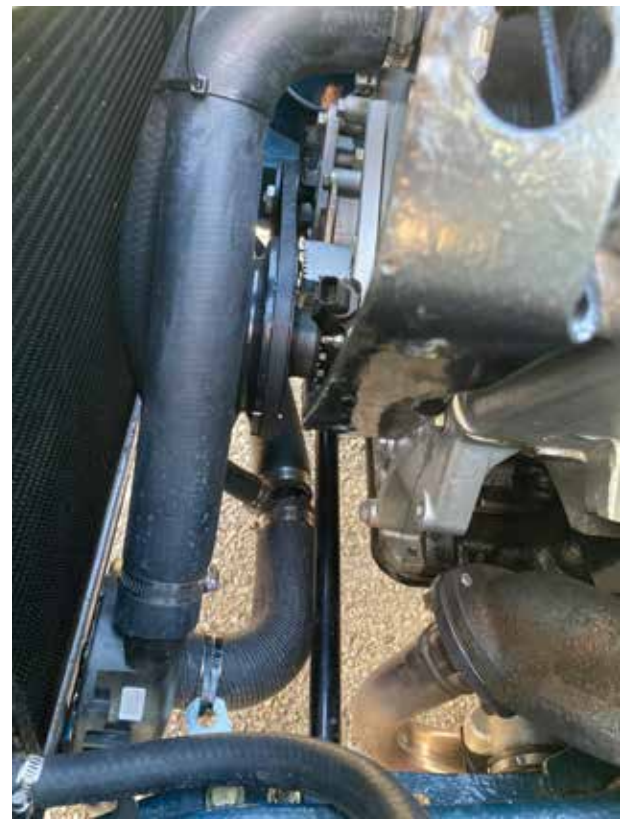
The EWP was mounted low on the left side

I had made the decision to go with an electric water pump so the oil and water holes in the block were plugged with simple Welch plugs (core plugs) and the Davies Craig Model EWP-115 was mounted low on the left side, which is only possible if the mechanical fan is removed. The thermostat was also removed, and the bypass deleted as the EWP controller, mounted in the glove box, would take over those functions. I had a decent Mk2 radiator which tested fine even after I had soldered two stubs in for a VW header tank, but on installation it sprung leaks everywhere. I

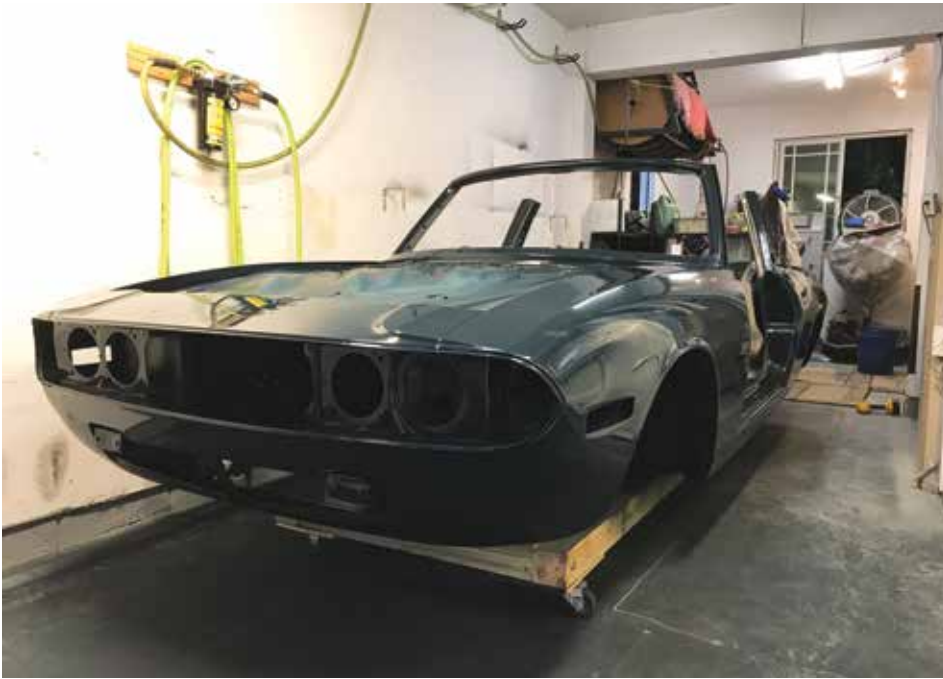
In the paint booth - garage!

This is the fourth car I have painted in my garage. It's not easy but I seem to manage it! I used PPG DCC paint which is expensive but sprays well. It's a two-part single-stage paint. When painting at home you are bound to get dust in the finish and colour sanding is a must, so I ensured there was plenty of paint on the car. Before that I had put a coat of epoxy primer on the bare metal, and on some spot areas where I did the body repairs, I applied and levelled the filler to where I wanted it and followed that with another two coats of epoxy. Then on went 4-6 coats of polyester hi-build followed by blocking and reapplying as needed, followed by another coat of epoxy as a sealer. This is the hard bit; it takes many hours but gives a good finished. A low humidity, warm September day was needed, and the garage had been cleaned, sealed off with plastic sheeting and five fans covered in filter material were used as extractors. Filters were used on the air inlet side as well. I did use an air-fed respirator as it still gets nasty in there. I purchased a Festool nib remover which is a tungsten block used to scrape paint nibs and runs from new paint. It worked very well, and I was glad I had it, despite its rather high cost! After a full colour sand and buff, the paint looks great.

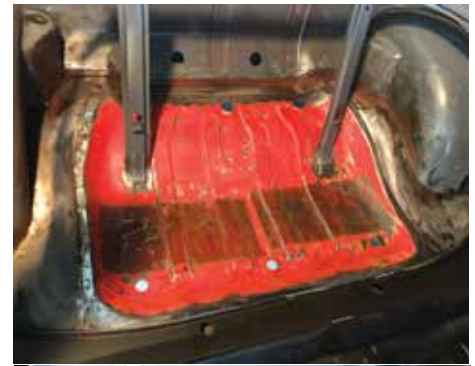
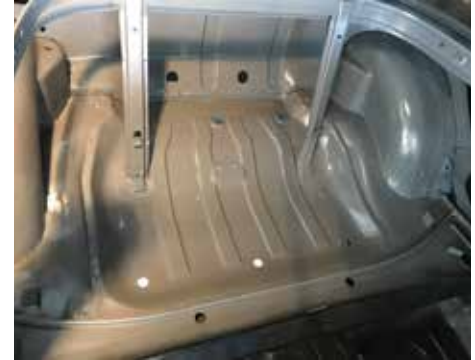
Rear seat panel before/after

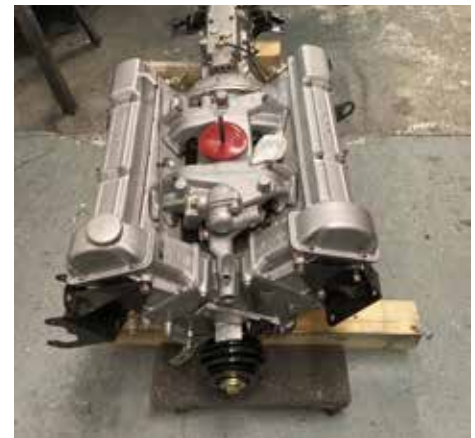
V8 ready for reinstallation

The heads were fine, so they had a valve job and light skim. The block was over-bored to +20 and lightly decked, the crank was reground -20 and the components balanced. However, I wasn't happy with the shop's assertion that cranks never

need hardening so sent it off to Shaft-Tech in Ohio for hardening and polishing. The engine was installed using German IWIS timing chains and the engine assembly went well. However, you do need to be on your best game with this engine as it is not simple and there are lots of items that need special attention. I had calculated the volume of everything before assembly and in the end with the new pistons and skimmed heads, the compression came out at 9.2:1 - just what I was looking for.
