STEERING RACK REBUILD

by Terry Hunt

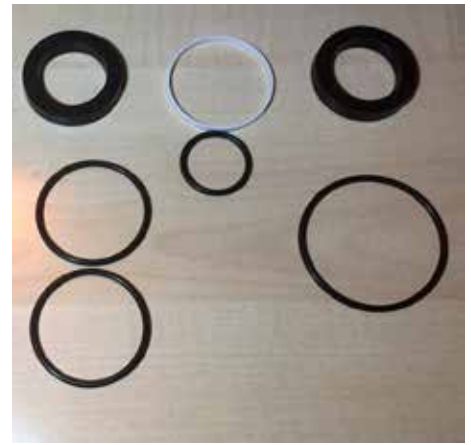
Rack seals as supplied in the kit

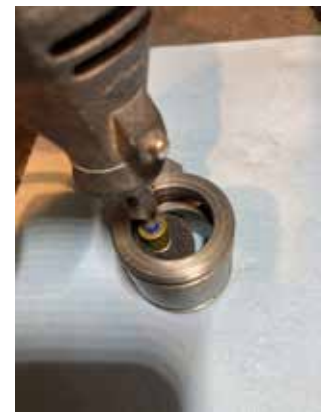
Cleaning out the main seal grooves

One thing to keep in mind is that the seals, including the main seals not only seal to the rack shaft but seal to the grooves they sit in. It is important to clean out those grooves and make sure they are OK. I use a Dremel with a Scotchpad disk to get inside the grooves to clean them.

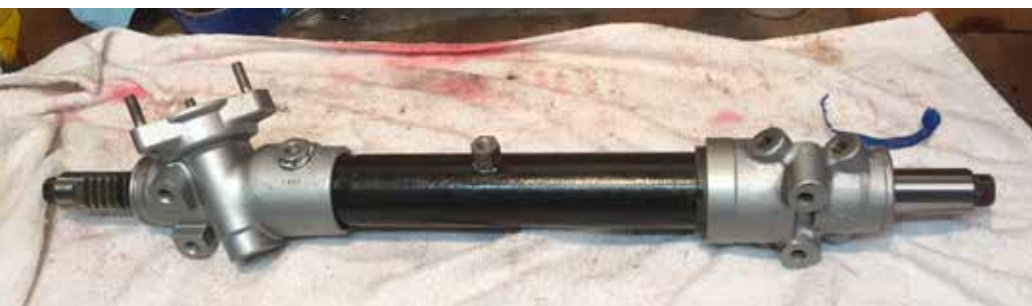
Refurbished rack

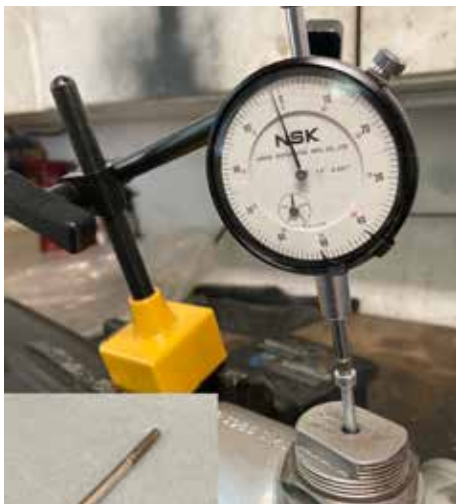
The plunger adjustment. Inset is the bolt I use

Before you install the tie rods install the control without its hydraulic lines, and the "thrust plunger" and do the adjustment as per the ROM. This is difficult but very important. I found a small hex bolt

that went in the hole and its head provided a recess to keep the dial gauge tip steady (this is also useful when centring the rack, as the exhaust gets in the way of anything longer) The hardest thing is finding a secure mount for the dial gauge, I clamped mine in a vice and used the vice jaws for the dial's magnet.

I suspect that my messing with this setting after the rack was installed, (searching for "stiffness") caused the leaks I experienced, perhaps due to the rack moving around too much inside the sleeve, thus damaging the seal. Its only 3-7 thou, a tiny amount and since I set it and left it well alone, I have had no leaks. Run the rack from one side to the other to assure yourself that it has no stiff areas and leave it alone!

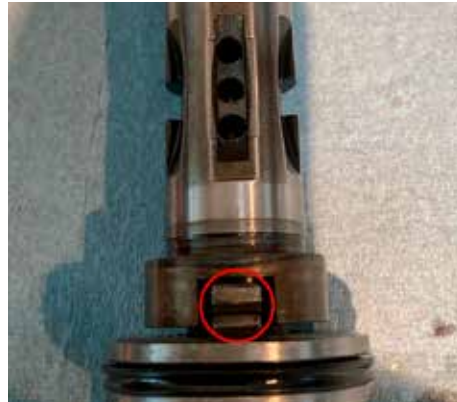
Mark the lug (circled) that aligns with the three slots

the input shaft, take care not to damage the shaft as you do that. The "bobbin" can be removed by releasing the wire circlip securing it to the output shaft, take note of how it is orientated as it can be installed 180 degrees out, but more on that later. Before going any further, mark the lug on the output shaft that is below the three slots in the input shaft as this needs to go back together in the same way.

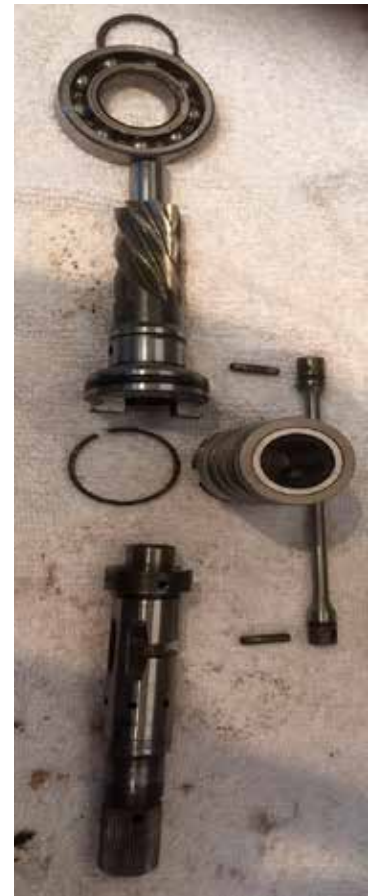
The disassembled control

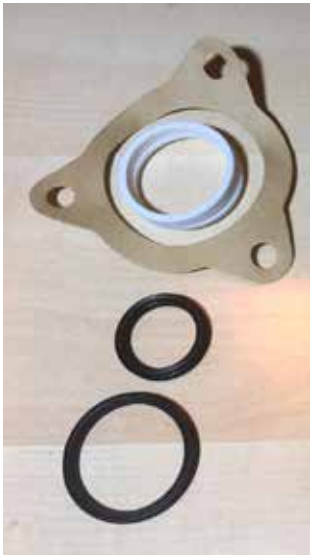
Control seals used for Alford & Adler controls

The control has three sets of seals, at the top and bottom there are X-type seals to keep the fluid in and the "bobbin" has four PTFE seals. There are also two seals on the torque bar. Many do not replace the PTFE seals if they look Ok but it's not too difficult. In all cases use some type-F transmission fluid to lubricate them. The seal kit has many seals that are not used - pictured are the ones used for Alford & Adler controls.

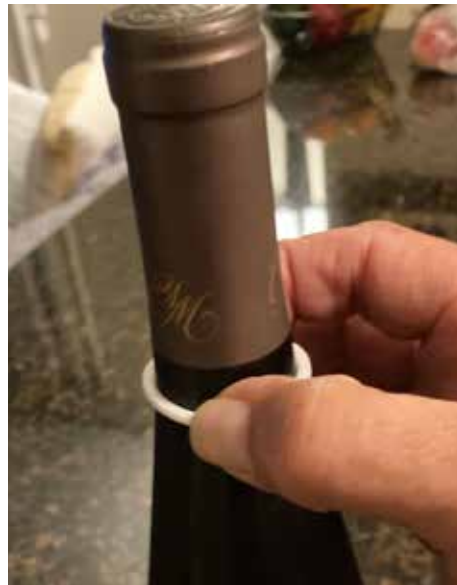
Stretching the heated PTFE seals over a wine bottle

The bobbin seals need to be stretched and "resized" to install them. I found that dropping them in some hot water for a few minutes and stretching them over a narrow-necked wine bottle works well.

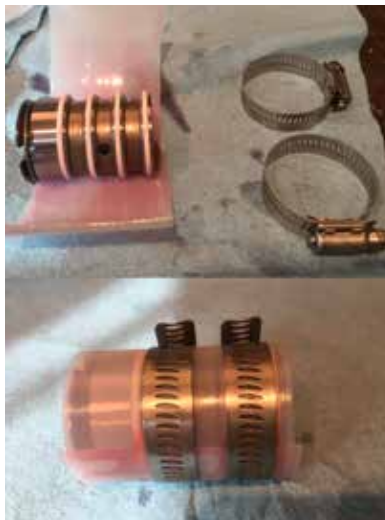
"Resizing" the seals

Don't overstretch, just enough to get them over to the position. Once they are in place, they will be too loose. Get some clear plastic sheet, (I used an old windshield wash gallon container) and two wide hose clamps. Put some transmission fluid over them and wrap the plastic around the bobbin, with the hose clamps around that making sure the seals stay fully in their grooves, tighten fully and then back the clamps off a turn or so to hold the seals in compression. Leave this for an hour or more and when you release the clamps the seals will be compressed enough to insert into the housing.

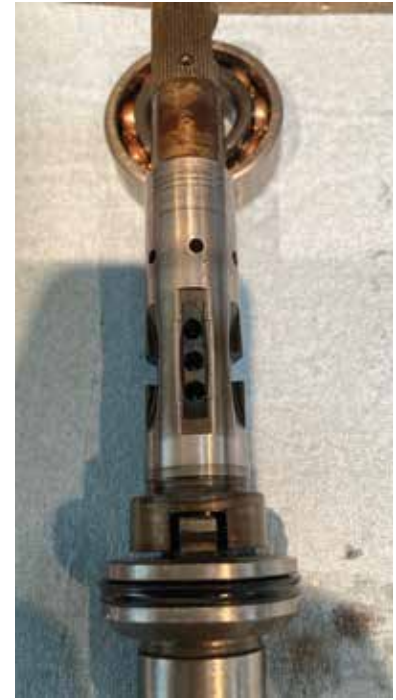
Before inserting the roll pins, ensure the lug is centred

the lug in the input shaft is centered in the slot in the output shaft as per the picture. You may need to spin the torque bar 180 degrees to achieve this. It is best to insert something in the roll pin holes to check this before finally installing the roll pins.

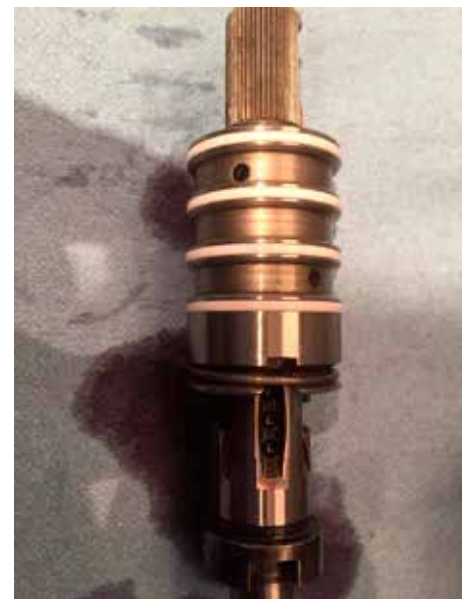
Align the two holes in the bobbin with the three slots in the input shaft.

The bearing can be pressed or drifted on now, then the bobbin which must be installed in the correct orientation as it can be put on 180 degrees out which has caused many an issue. Inside the bobbin there are two grooves which line up with the three large slots in the input shaft. Another check is that as you are installing if you orientate the input shaft to look at the large slots the bobbin will show two holes top and bottom, as in the picture. Once in place make sure the wire clip is installed to hold the bobbin in place.

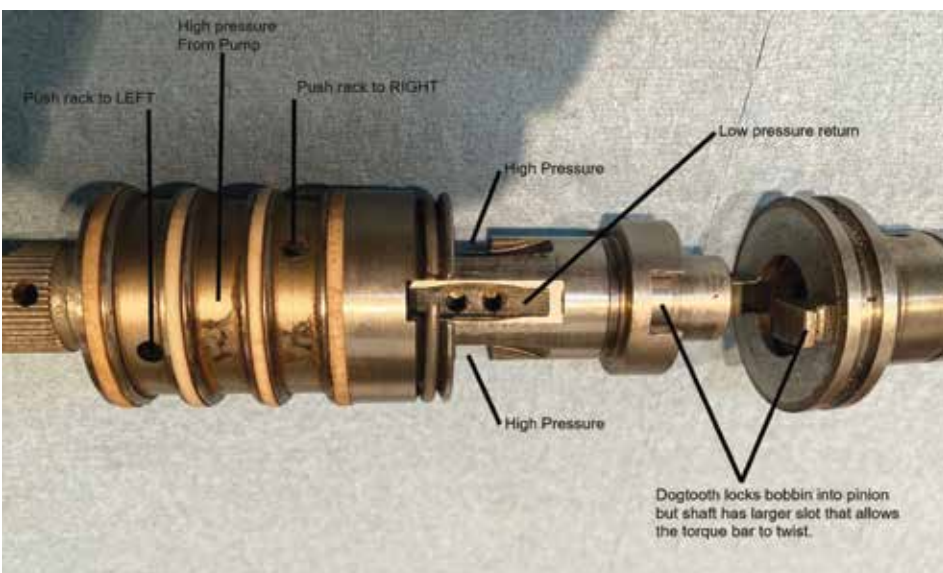
The key is that centered lug. It is held central by the torque rod. When you turn the steering wheel the torque rod gives way a little and one of the slots inside the bobbin aligns with an outside slot in the input shaft feeding high pressure to one side of the rack. At the same time the other bobbin slot opens a path to allow fluid to escape from the other side of the rack, through the centre slot back to the pump.

How the control works
